Ignition Switch - Sedona

INSPECTION

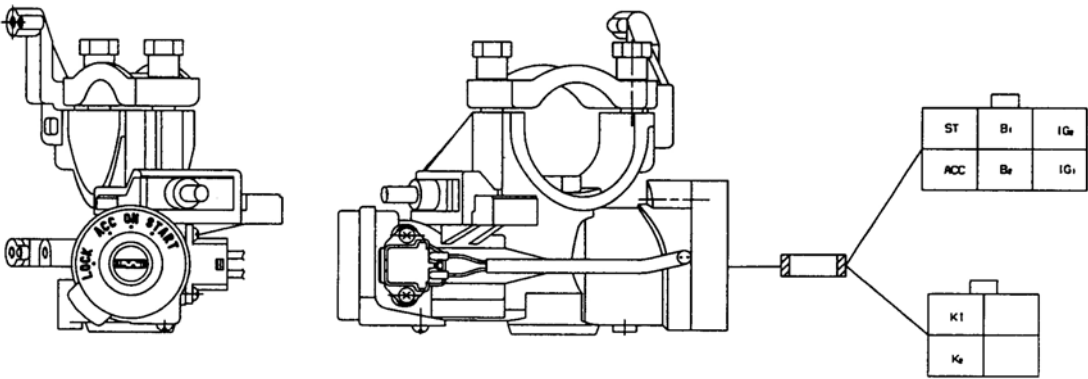
G00402614

- 1. Disconnect the connector under the steering column.
- 2. Check the switch continuity between the terminals specified below.
- 3. If continuity is not within specification, replace the switch.

Fig. 2: Illustrating Switch Connector Pinout
Courtesy of KIA MOTORS AMERICA, INC.
